Bianchi's internal test laboratory has recently detected a possible error on seat clamp assembly of our Aria road bike model.

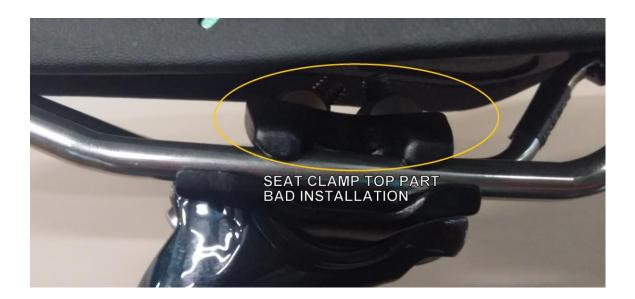
In some samples, the top part of seat clamp could have be installed in reversed position; this issue could compromise the seat clamp functionality making difficult to place the saddle in 0° position and, more important, can lead to a not properly working seat clamp's screws with a dangerous overstress.

Wholesalers, distributors and dealers shall check all bicycles in their stock before final customer delivery and, if necessary, disassemble and re-assemble the seat clamp in the right position (see attached pictures).

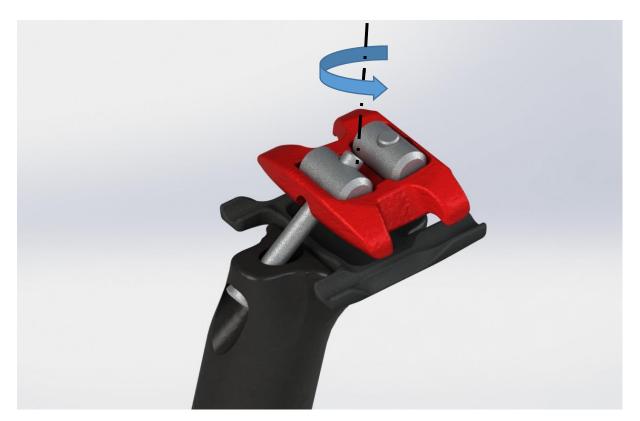
In case you find your seat clamp is assembled in wrong position, proceed as follow:

- 1. remove the saddle,
- 2. remove both screw and bottle nut
- 3. rotate the seat clamp top part (red component in picture below) of 180° around a vertical axis
- 4. re-assemble the seat clamp and install the saddle.
- 5. check if the seat clamp is correctly installed (refer to picture above)
